**Gilsland**

# **Infiltration Reduction Plan**

**Last Updated:** January 2026

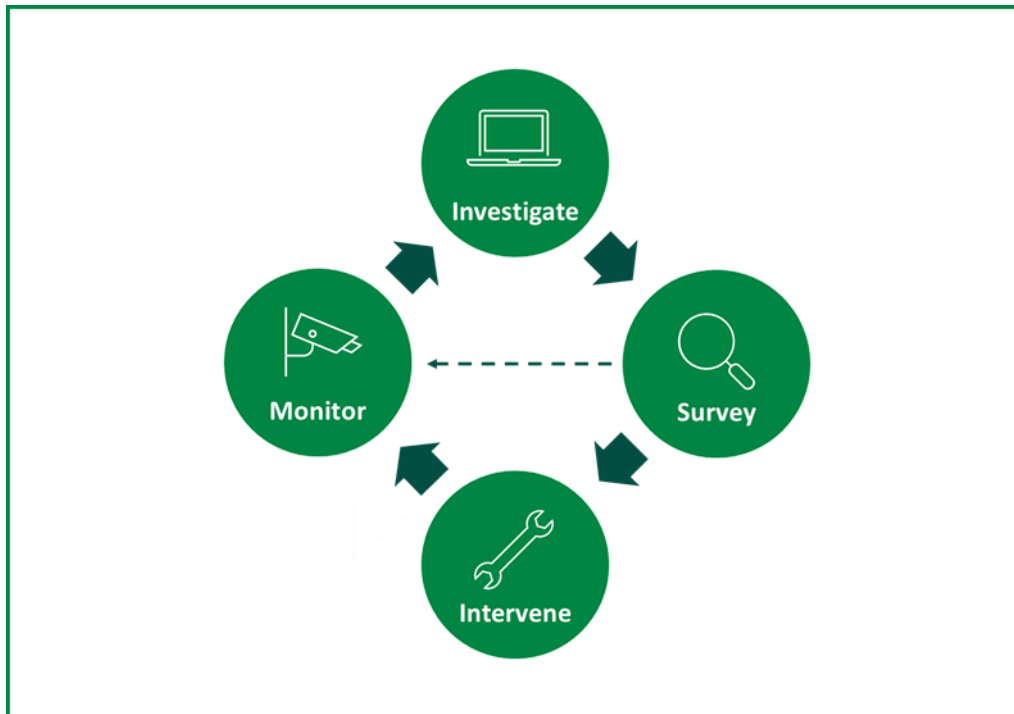
**Figure 1:** Iterative process to investigate, identify and address groundwater infiltration

Gilsland is currently in the intervention stage (see Figure 1) to address infiltration and reduce spills at the Gilsland Wastewater Treatment Works Storm Overflow (017670091SO). An initial desktop assessment concluded that groundwater infiltration in the catchment was possible. Surveys have confirmed the presence of infiltration, and interventions are currently underway as a result.

Gilsland is currently in the intervention stage of identifying and addressing infiltration. The site will then follow the iterative process displayed in Figure 1 to monitor the efficacy of these interventions and identify new points of infiltration, should they arise.

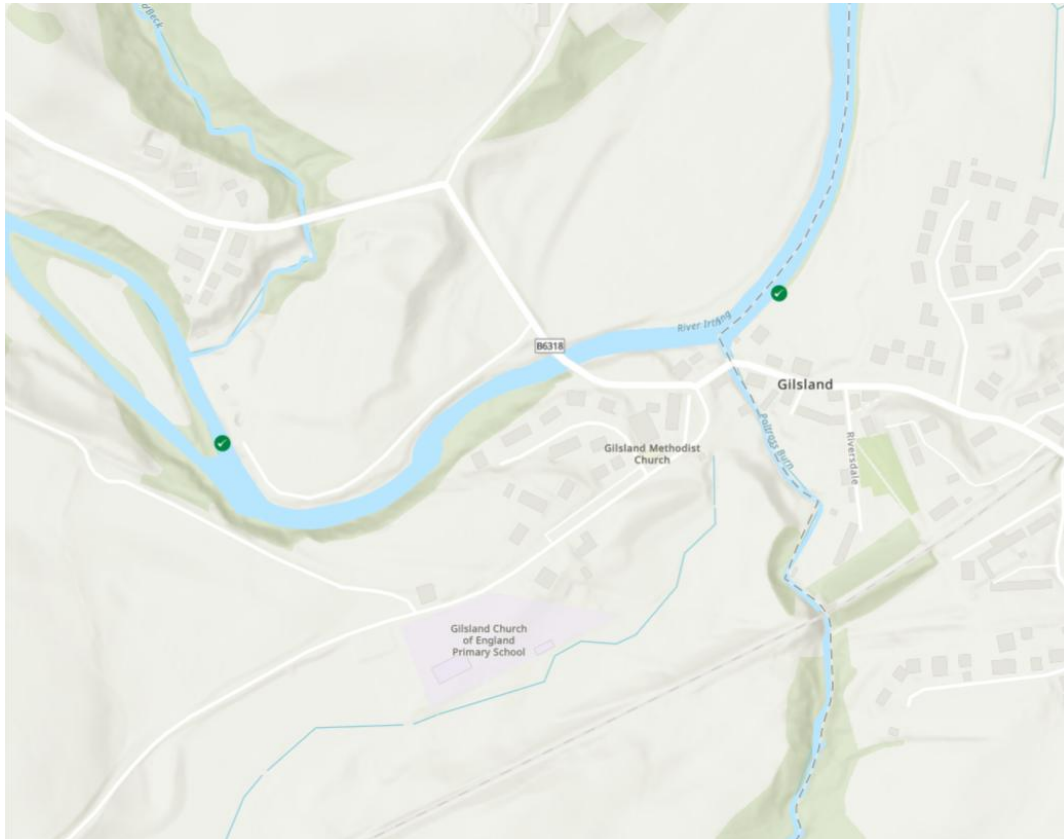
**Figure 2:** United Utilities – Better Rivers – Storm Overflow Map (November 2024). The green dot on the left of the image marks the Gilsland Wastewater Treatment Works Storm Overflow.
