Great Orton

Infiltration Reduction Plan

Last Updated: January 2026

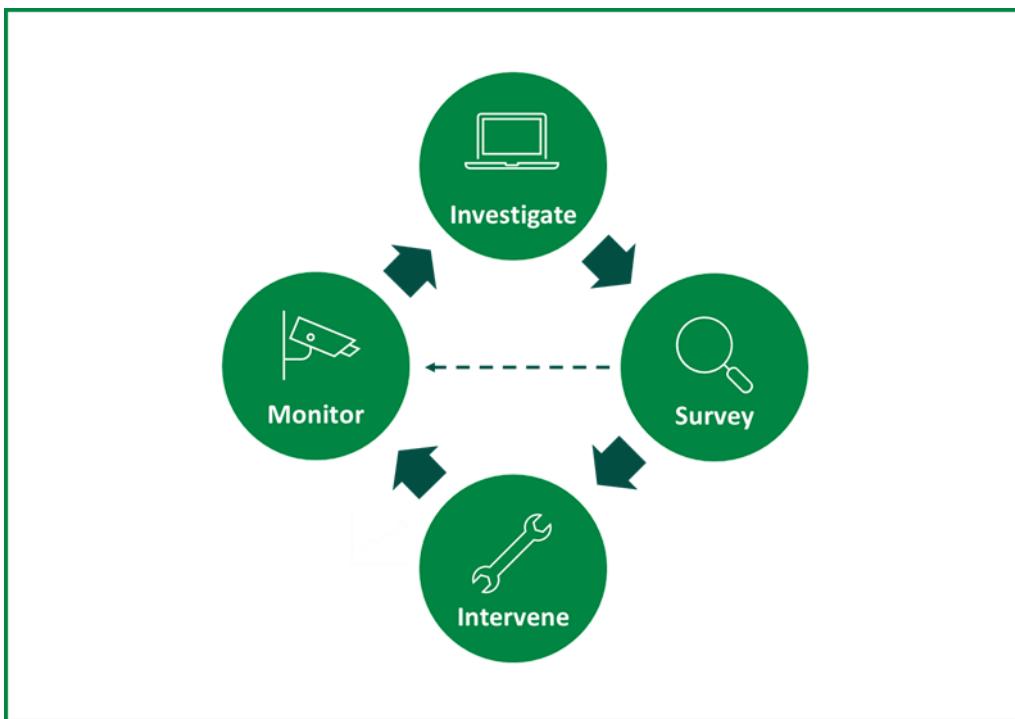
Figure 1: Iterative process to investigate, identify and address groundwater infiltration

Great Orton in Cumbria is currently in the intervention stage (see Figure 1) to address infiltration and reduce spills at the Great Orton Wastewater Treatment Works Storm Tank Overflow (017670128ST). An initial desktop assessment concluded that there was the possibility of groundwater infiltration. CCTV surveys have confirmed infiltration, and interventions are due to be completed in Winter 2026.

Great Orton is currently in the intervention stage of identifying and addressing infiltration. The site will then follow the iterative process displayed in Figure 1 to monitor the efficacy of these interventions and identify new points of infiltration, should they arise.

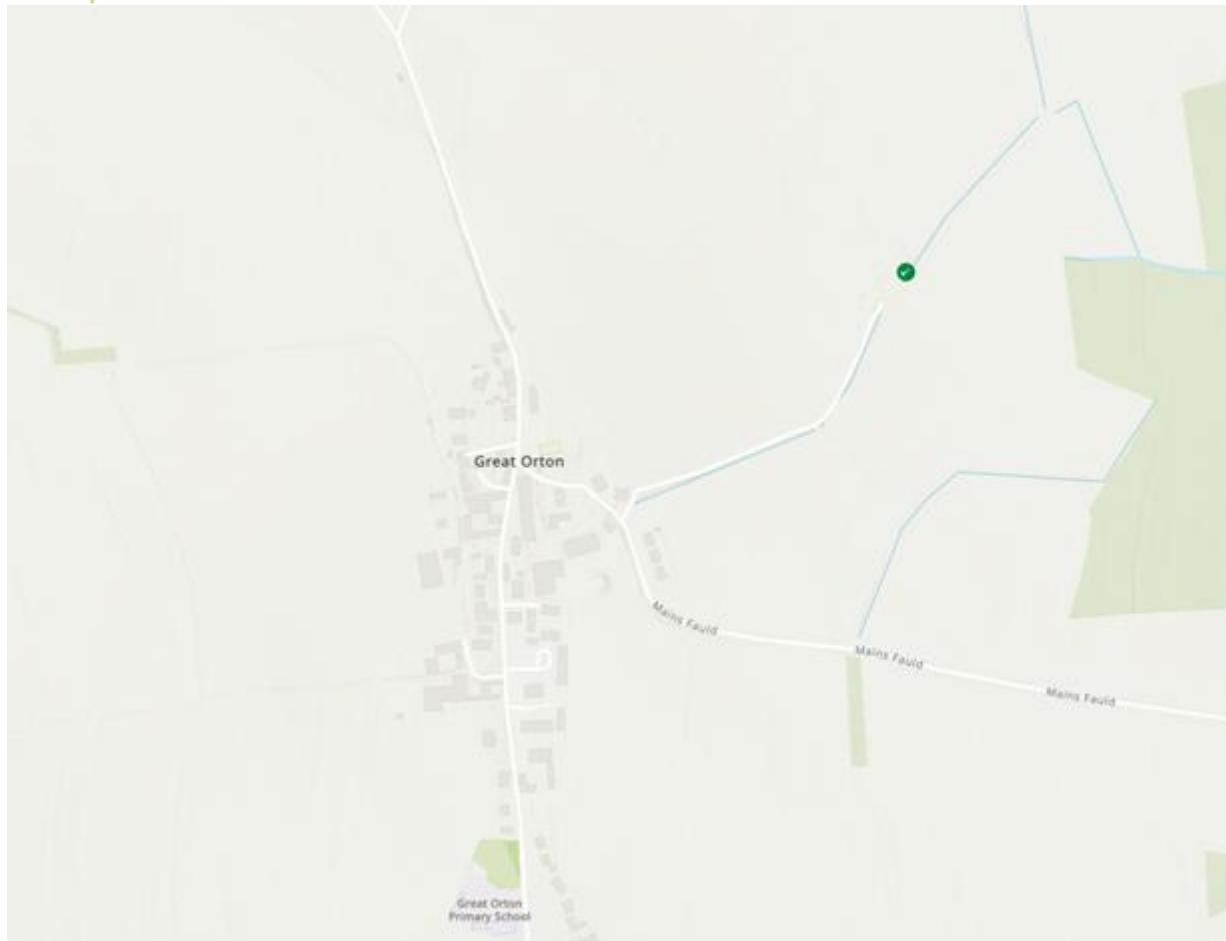
Figure 2: United Utilities – Better Rivers – Storm Overflow Map (September 2024). The green dot marks the Great Orton Waste Water Treatment Works Storm Tank Overflow.

Great Orton is a small village in Cumbria, south of Wigton. It is surrounded by rural land and discharges to Roughton Beck.
