# **Ireby**

# Infiltration Reduction Plan

Last Updated: July 2025

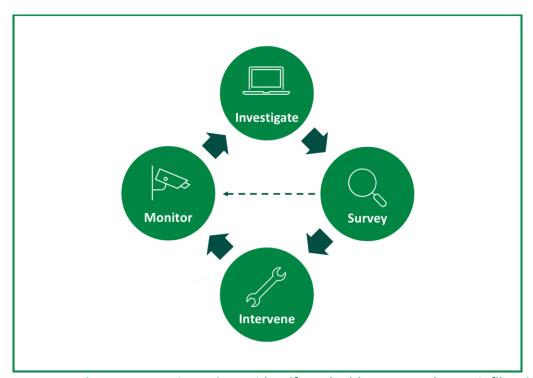
Figure 1: Iterative process to investigate, identify and address groundwater infiltration

Ireby in Cumbria is currently in the monitoring stage (see Figure 1) to address infiltration and reduce spills at the Ireby Wastewater Treatment Works Storm Overflow (017570071SO). A desktop assessment concluded that there was a low likelihood of groundwater infiltration, however surveys confirmed points of infiltration and remedial works were completed in March 2025.

Ireby is currently in the monitor stage of identifying and addressing infiltration (see Figure 1). The site will follow the iterative process displayed in Figure 1 to monitor the efficacy of remedial works and identify any more significant areas of infiltration, should they arise.

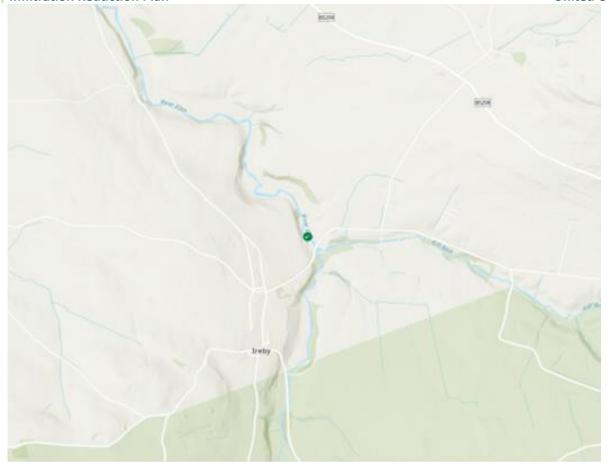
**Figure 2:** <u>United Utilities – Better Rivers – Storm Overflow Map</u> (October 2024). The green dot marks the Ireby WwTW Storm Overflow.
