Barrow Nook

Infiltration Reduction Plan

Last Updated: March 2026

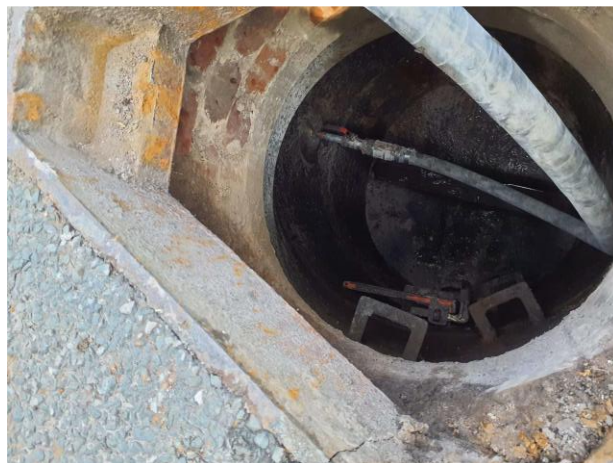
Figure 3: Grout injection to seal a manhole

As recommended, remedial works were completed in May 2025. This involved lining 72m of the network to seal it and prevent infiltration. Point infiltration at one manhole was addressed by sealing it using tunnel grout at two injection points. The image below shows the grout feed hose filling the void around the manhole, creating a watertight seal.
