I - Take Photo

Main

Contract/Area code	456/005-Arqiva UU Smart Metering - External West and North
Agent	[redacted]
Gang	[redacted]
Region	Northwest
Operator Name	[redacted]
Address	[redacted] Bury Road [redacted]

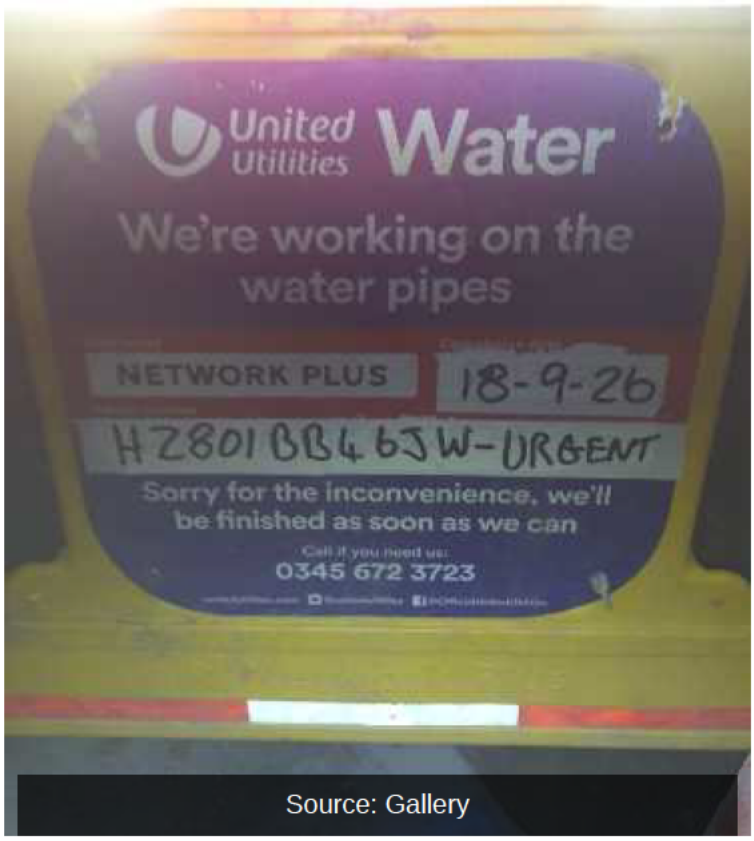
Comment	Dug down on outlet of box followed pipe to point to point of entry no leak on pipe or box water coming from the cavity wall plumber on the way to fix this now customer happy leak not on public
Photo
