How we do it

Slip lining process

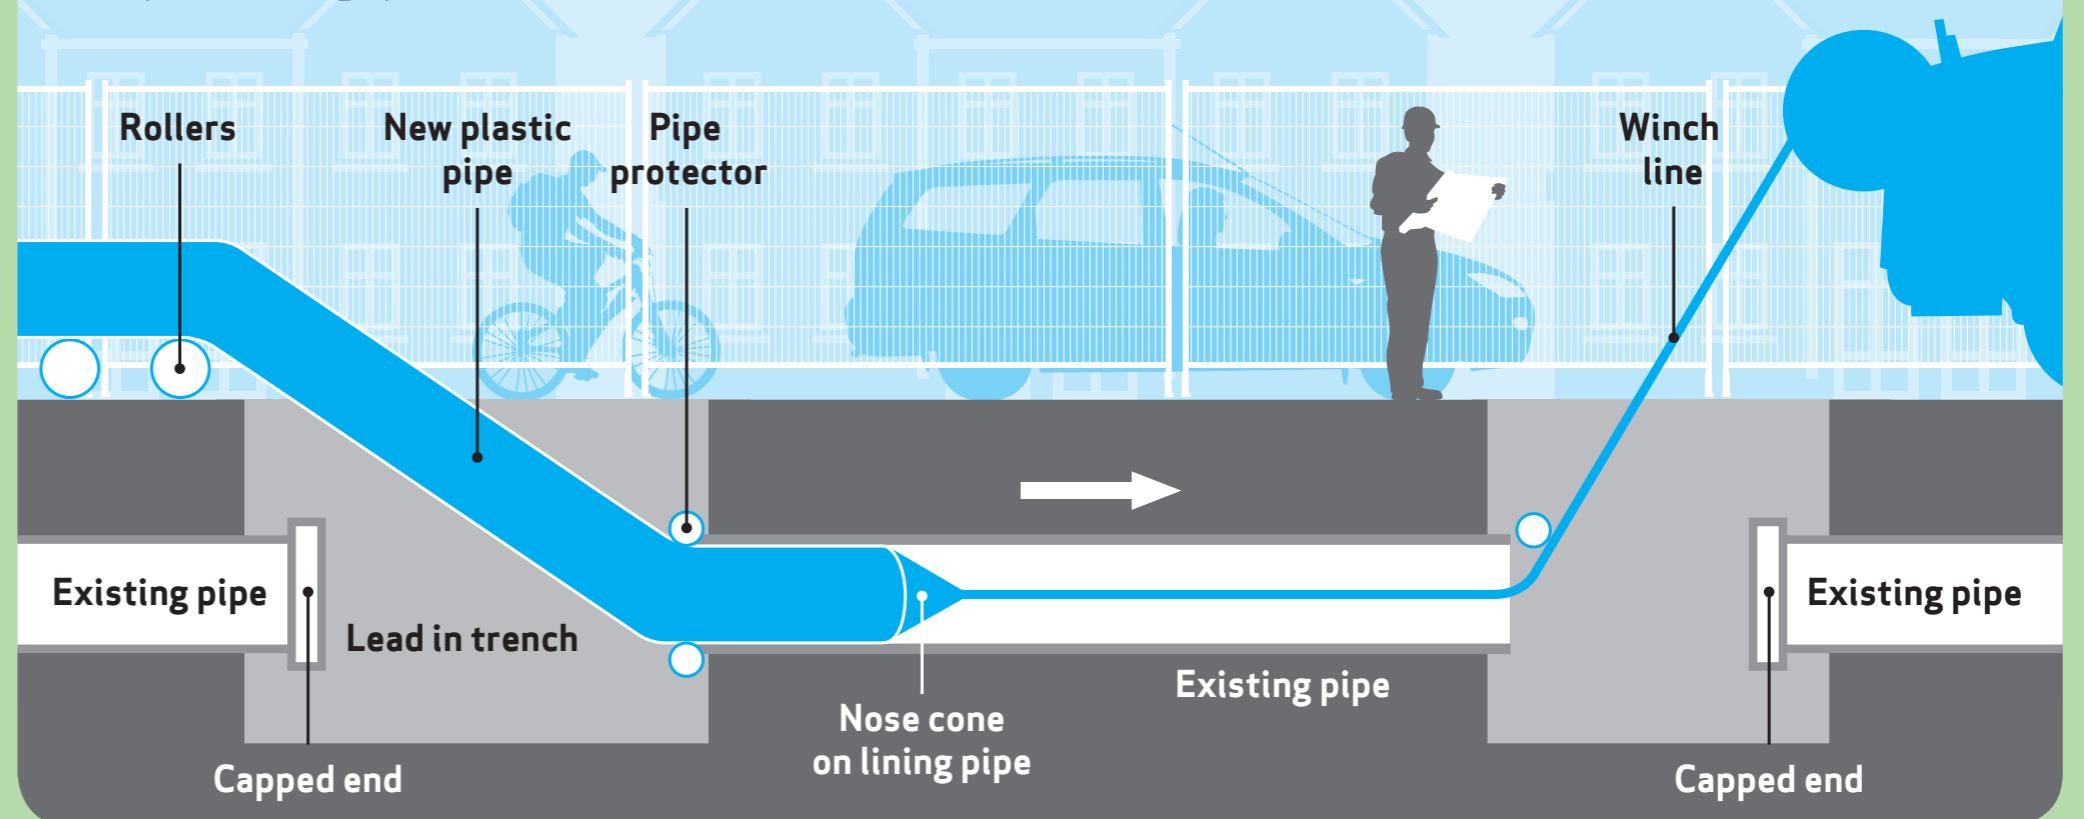
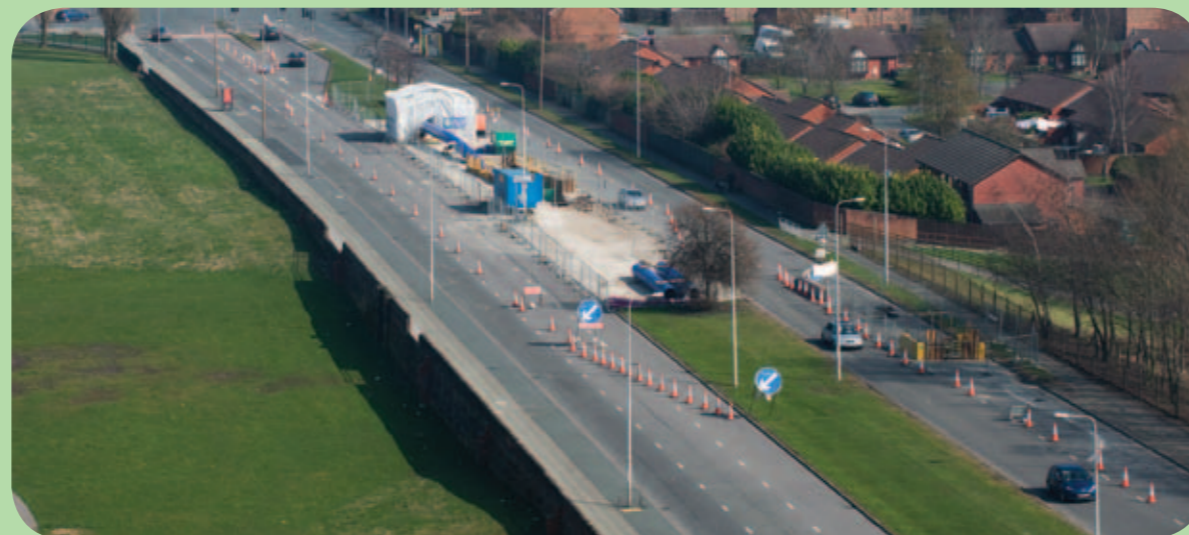
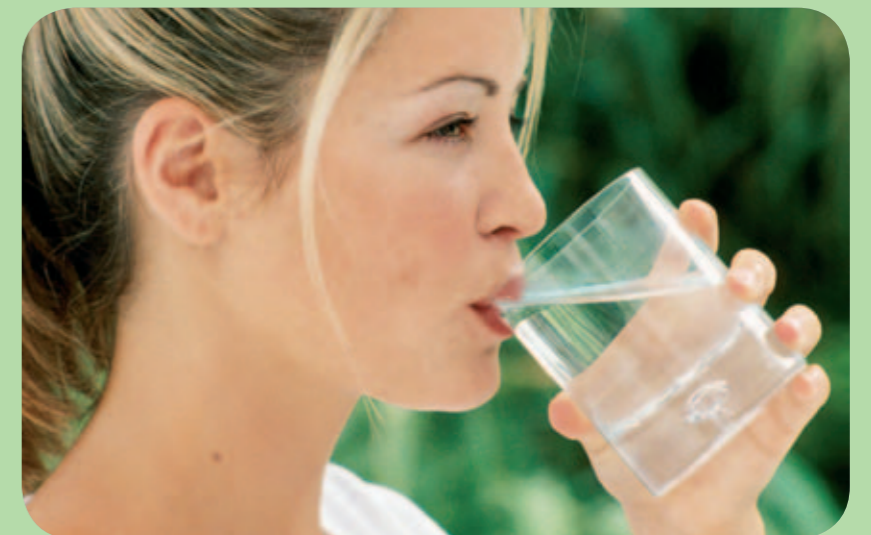
The diagram below shows the slip lining process:

- The existing pipe is exposed, cut and capped at two points
- The open section of the existing pipe is cleaned
- A nose cone is placed on the new pipe and drawn through the existing pipe via a winch
- The new plastic pipe is tested before being connected to the water network.

The procedure inserts a new pipe inside the existing pipe by pulling it through with a winch. The new pipe is of a smaller diameter than the existing pipe and to allow for a trouble free insertion the existing pipe is often cleaned first.
