Crummock Water Restoration

Crummock Water – Weir Modifications

Crummock Water – Weir History and Water Level Schematic

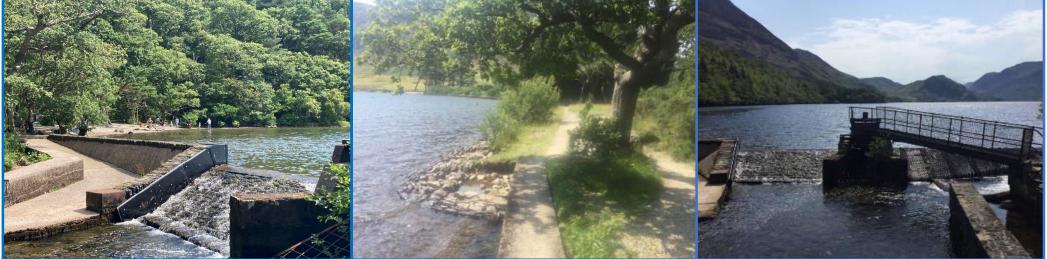
Proposed works:

- Remove weir and abstraction infrastructure
- Restore the two outflow channels (River Cocker)
- Retain existing vegetated island
- Reprofile the river bed in immediate area around weir removal

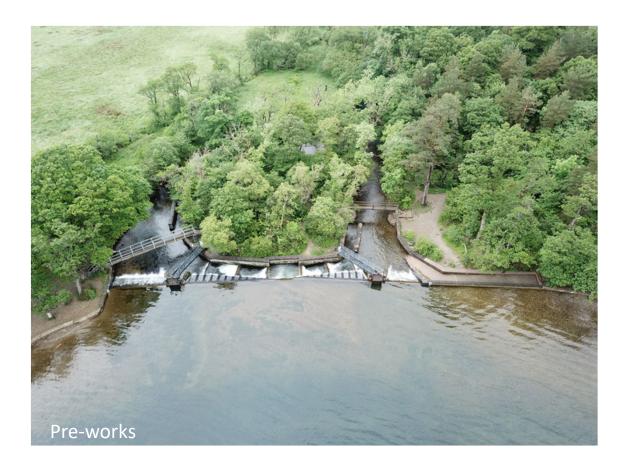
Crummock Water and River Cocker

Restoration benefits include:

- No hard infrastructure acting as a barrier/obstruction so improves connectivity for biota and sediment
- Provides a more natural channel and flow regime, enhancing morphological and ecological habitat diversity
- Improves fish passage/migration
- Promotes a more natural variation in Lake water levels, improving shoreline habitat diversity
- Reduces flood risk downstream

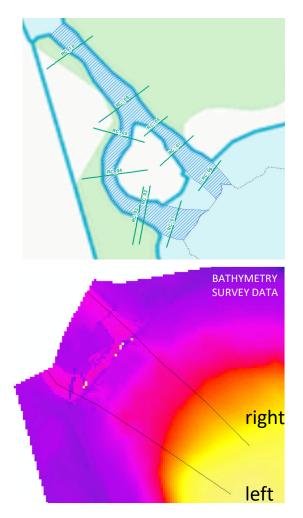
Crummock Water Bathymetry

WESTERN RIVER COCKER CHANNEL OUTFLOWING FROM CRUMMOCK WATER

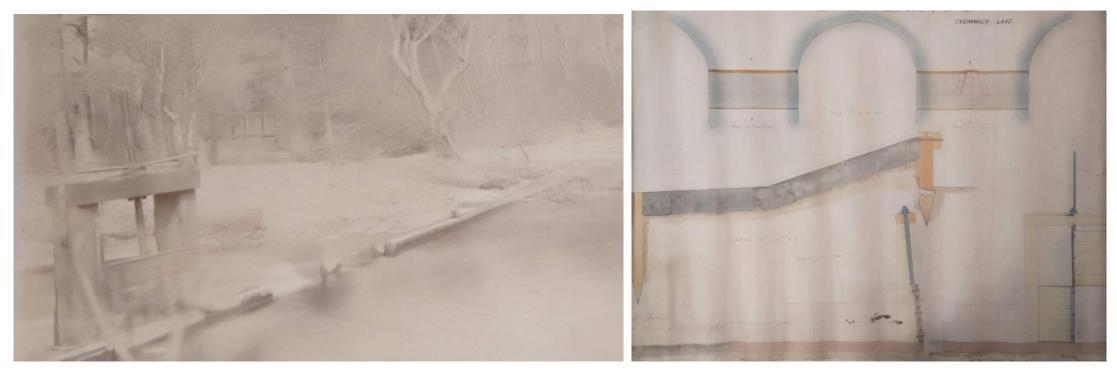
Crummock Water – Timber Weir

The photograph (left) demonstrates that the crest of the weir is higher than the bed level of the River Cocker downstream. The sketch (right) depicts the fish pass on the right side of the weir and the sluice gate on the left side of the weir

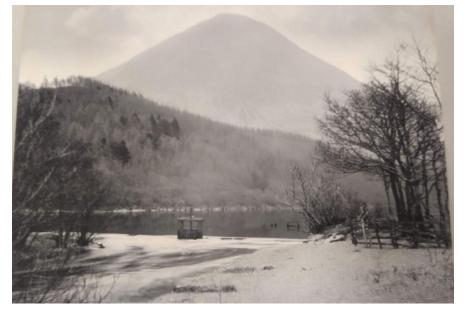
Crummock Water – Timber Weir

At high water levels the timber weir became submerged. This also happens with the existing weir at high flows.

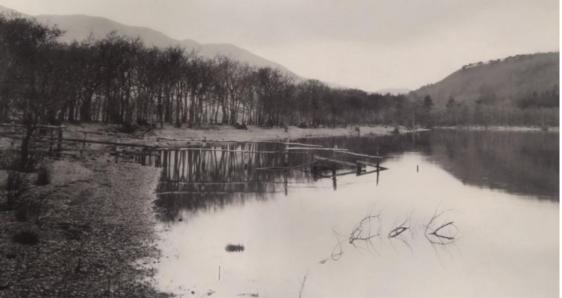
The shoreline of Crummock Water is gravelly; the lake level will fluctuate with rainfall / tributary inflow as it did in the 19th century and as it does currently. Removal of the existing weir and re-profiling of the River Cocker channels will reduce the outflow potential, and the range of lake levels will fluctuate more widely following weir removal. Hydraulic modelling suggests the peak water level will be up to 1.5 m higher for a Q100 flood event (1% annual exceedance probability; 1:100 year flood event), compared to approximately 1 m now.
